HERITAGE STATEMENT

Alterations at Dormers, Bessels Green Lane, Bessels Green TN13 2PT

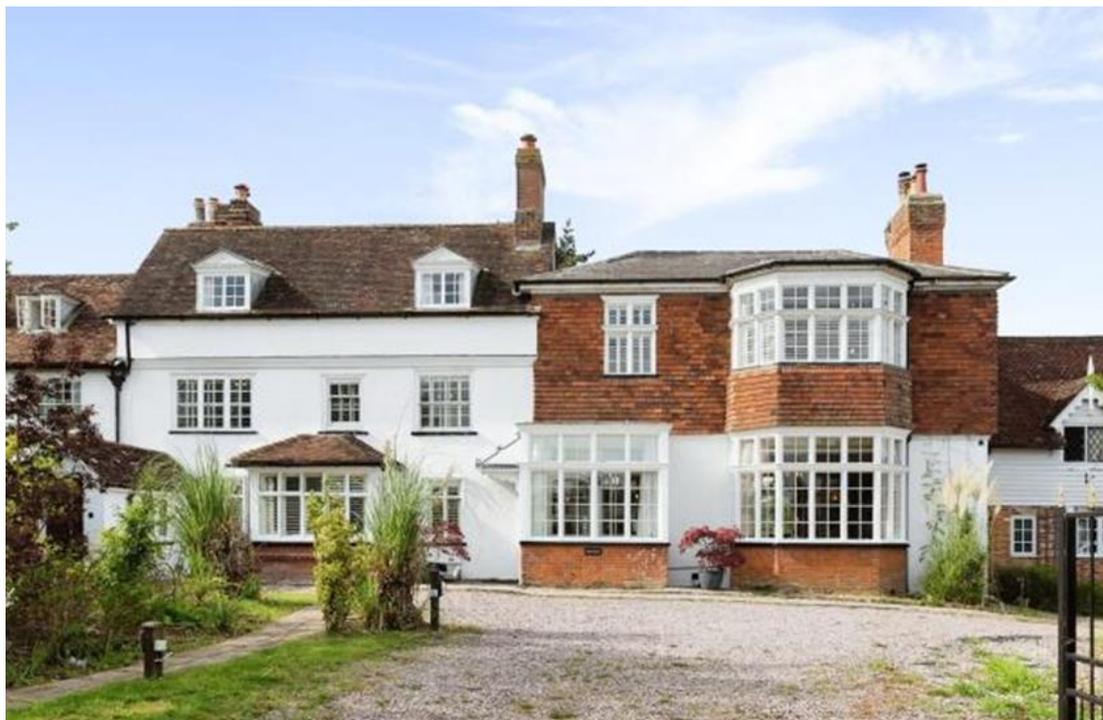
- 2.6 Architectural analysis reveals that Dormers consists of two main phases of construction (**plate 1**). The two phases are reflected in the architecture of the front elevation: the left part is a mid-18th century rendered Georgian elevation with two storeys and attics, a steeply pitched peg tile roof, and a deep cornice. Most but not all of the Georgian windows have been altered and a square bay window added, but there is no doubt that this was once a polite symmetrical Georgian elevation with a central entrance in the position of the later bay window. In the third quarter of the 19th century (the list description suggests early to mid-19th century) a substantial extension was added to the right in a vernacular revival Arts and Crafts style with a hipped slate roof above a tile-hung first floor and a rendered ground floor. Internally the extension provided a more imposing entrance hallway, a grand staircase and a music salon.

Plate 1: Front elevation showing the original Georgian elevation (left) and the mid-to-late 19th century extension (right)

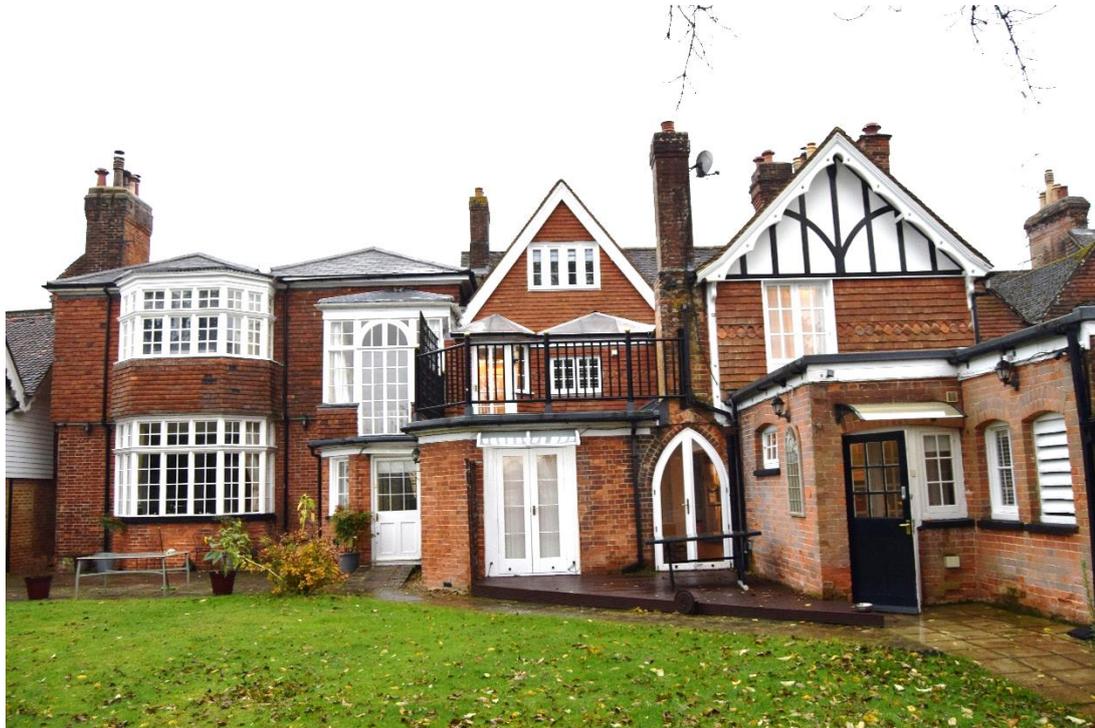
Plate 2: Rear elevation

- 2.7 Contemporary with the north extension, the house was also extended at the rear, completely concealing the rear of the original Georgian House (**plate 2**). The resulting rear elevation is a lively mix of gabled and hipped architectural elements reflecting the complexity and function of the rooms within. Such an approach owes much to the principles of the Gothic Revival. However, the extensive use of tile

hanging, mullioned bay windows with small-paned windows and exposed timber framing is all attributable to the Arts and Crafts movement.

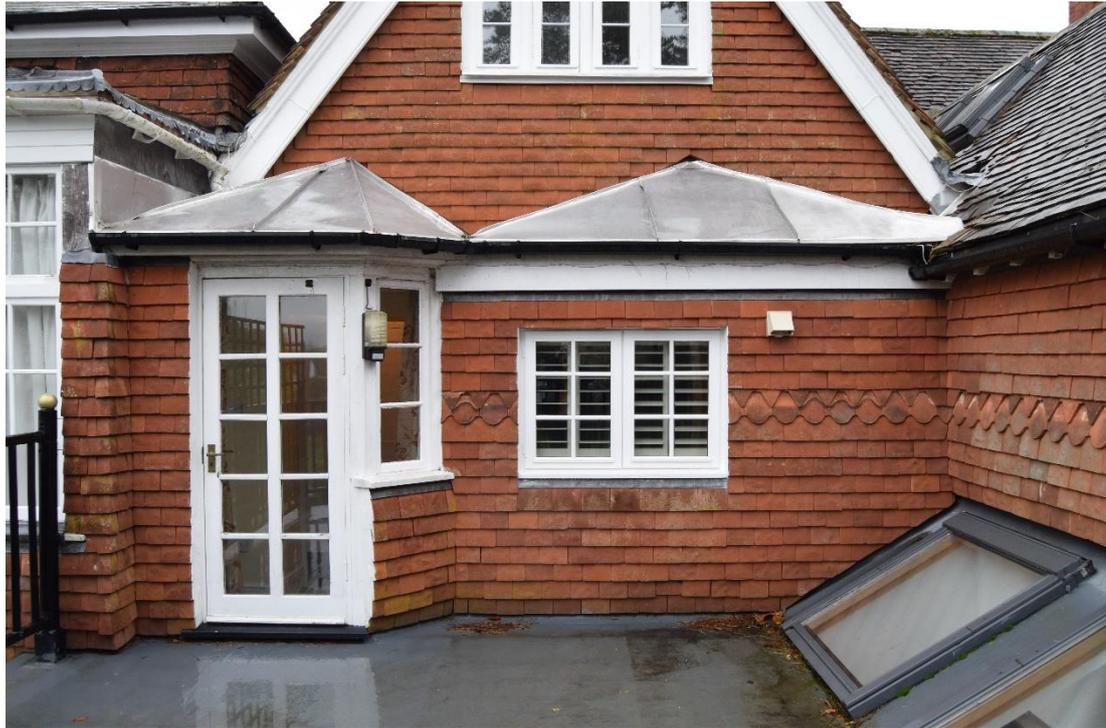
3.5 The solution that was agreed between the structural engineer, the building inspector and the Conservation Officer was to move the first floor wall rearward (by approximately 1.2m) to align with a structural beam, effectively making the bathroom larger (**plate 3**).

3.6 Changes which arose as a direct result of the realignment of the rear wall included the retention of the small closet (rather than its demolition which had been approved) which was adapted to give access onto the balcony; relocation of the bathroom door to provide direct access to bedroom 3 rather than from the landing; and a reduction in the size of the approved lantern light on the flat roof.

Plate 3: Rear view of first floor bathroom extension with retained closet (left) and bathroom (right)

3.4 The most significant departure from the 2011 consents was the alteration to the family bathroom. During the implementation of the consents in 2011/12 it became clear that the rear first floor wall was in very poor condition. The tile hanging was heavily decayed and bedded on cement mortar, consequently the softwood stud wall was in poor condition. However, the main issue was that it lacked structural support at first floor level and urgent action was required to stabilise the building.

3.7 Externally, the modest extension was designed to complement the design and the roof form of the existing closet. Its architectural form and materials add to the varied mix of building forms which characterise the rear elevation of the listed building. Loss of a section of the stud wall was considered essential by those present at the time in order to achieve structural stability and achieve the conservation aims.

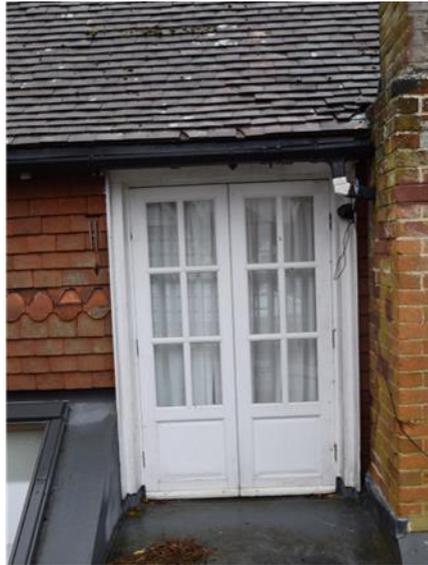
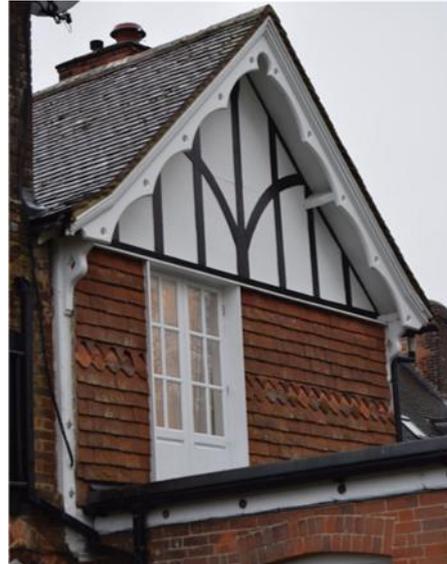
3.8 Replacement windows to bedroom 3 were approved in the 2011 consents. However, during the course of the alterations in 2011/12, the rear (west) and the side (north) windows (**plates 4 and 5**) were changed to French doors, providing access on to the flat roof/balcony.

Plates 4 and 5: French doors on the north (left) and west elevation of bedroom 3

- 3.9 As there is no consistency to the window/door types on the rear elevation, the change from casement windows to French doors has little or no impact upon the eclectic character of the rear elevation.

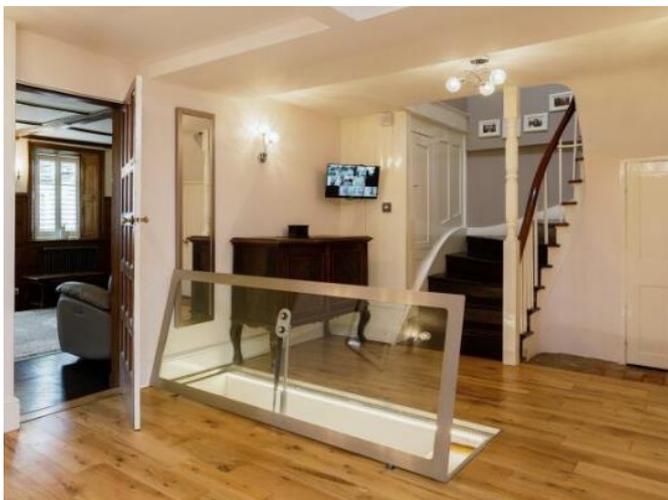
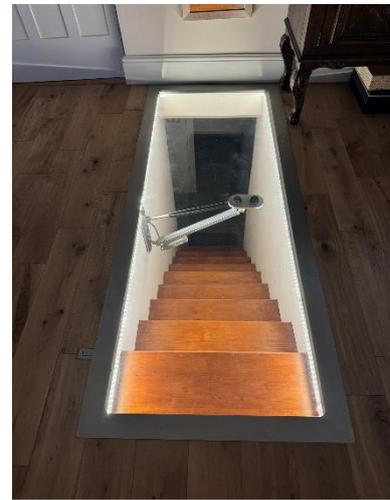
- 3.10 The 2011 approvals provided for new handrails and a gate either side of the cellar stairs.
- 3.11 During the works the applicants omitted the approved handrails in favour of a glazed door in the plane of the floor (**plates 6 and 7**). This elegant solution retains the visible presence and legibility of the cellar staircase whilst creating an unimpeded openness to the space.

Plates 6 and 7: Glazed cellar door in place of balustrades and gate

3.12 This simpler solution avoids the risk of the modern balustrades competing with and potentially devaluing the significance of the elegant Georgian balustrade and newel post. The Georgian staircase is perhaps the most significant survival from the Georgian house and is located just a couple of metres from the cellar stairs. As such, the heritage impact of the change is positive.

Originally, we intended to install a traditional balustrade, but after trial and error, none were satisfactory in safety or appearance. Ultimately, we installed an automatic glass floor door, which improved light and safety and allowed the staircase to be fully revealed.

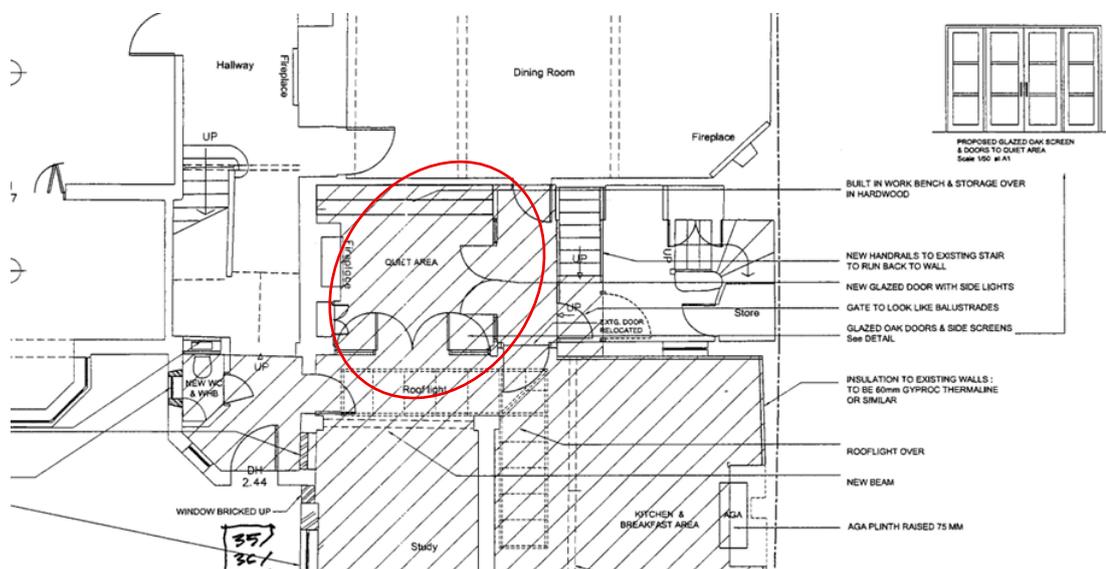
3.13 The 2011 permission included glazed screens around the room called “quiet area” on the approved plans (**figure 1**). The screens were installed in accordance with the consent but were later removed to create a more open-plan space and improved circulation.

Figure 1: Approved plan showing the location of the glazed screens installed in 2011/12

3.14 The application seeks to regularise the removal of the modern glazed screens and doors which were installed in accordance with the 2011 consents but later removed.

3.15 The screens/doors, which were off-the-shelf items purchased from Wicks, were of no intrinsic value and arguably detracted from the quality of the interior. Although they marked the position of earlier walls, their removal achieved better openness and improved circulation.

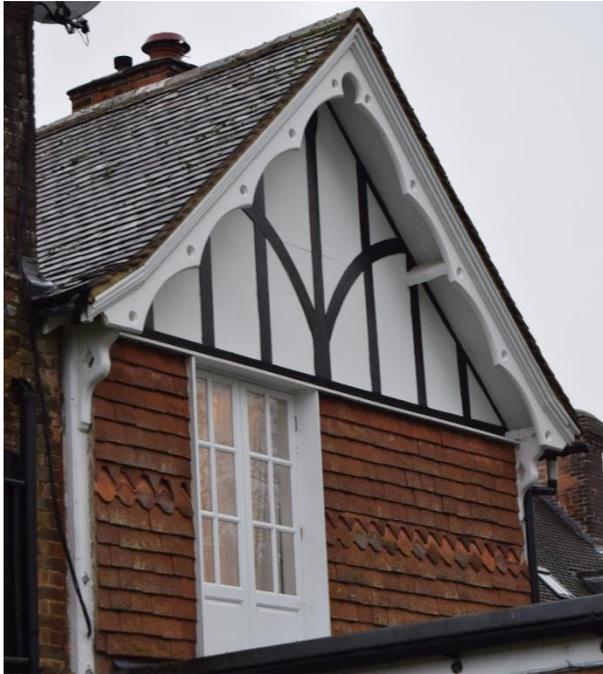
3.16 As part of the 2011/12 conservation works, deteriorated tile hanging was stripped off the rear elevation. The removal of the tile hanging from the rear gable above

bedroom 3 revealed the original black and white truss which was originally intended to be exposed (**plate 8**).

Plate 8: The gable feature which was uncovered during the 2011/12 restoration

- 3.17 In consultation with the Conservation Officer it was agreed that the timber framing within the gable should be left exposed to reveal the original feature and restore the original appearance of the elevation. The application seeks to regularise the position.
- 3.18 The heritage impact of removing the tile hanging and restoring the decorative gable was positive.
